Manhole Inspection Summary

Manhole # S29I__058MH

Insp Date: **4/6/09 11:02 AM**

Location Address: **S MLK JR BLVD**

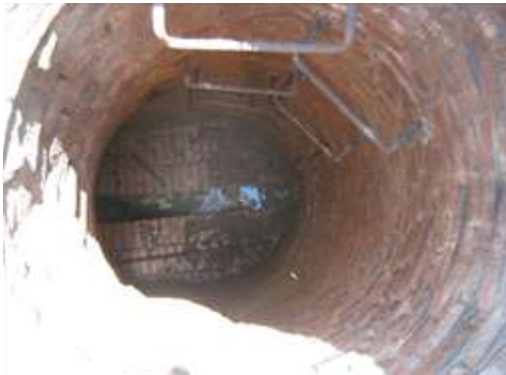
Top View

12 oclk is under the street unable to get top view this is the 3 oclk pipe leading in to the channel

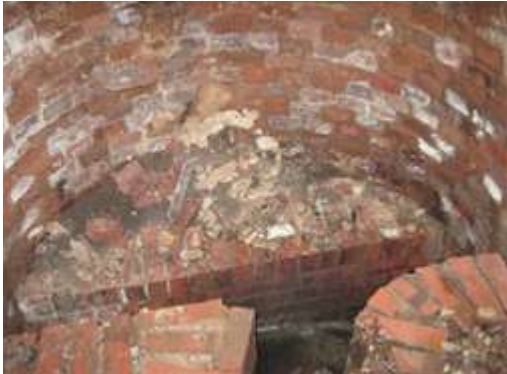
Miscellaneous

View of channel under mh shelf (12:00 to the right; 3:00 to the bottom; 6:00 to the left)

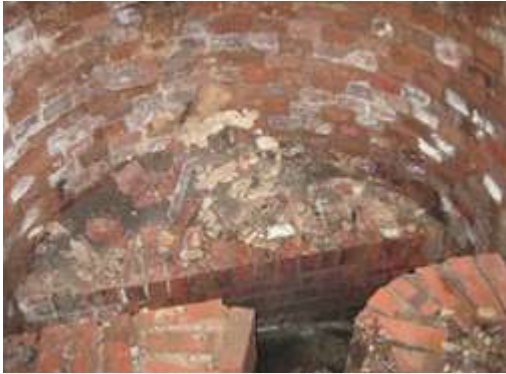
Defect 3

Condition: ☐ Sound ☐ Cracked ☐ Root Intrusion ☐ Deteriorated ☐ Leaks ☒ **Debris**

bench debris

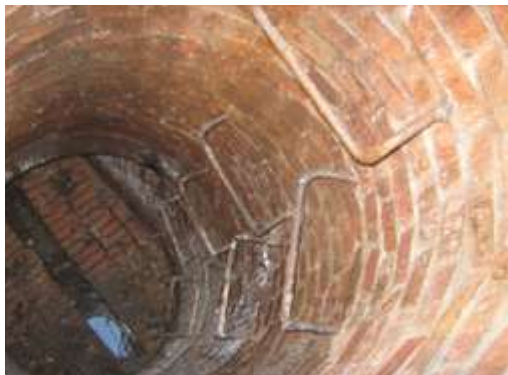
Defect 1

Steps Count: **11** Missing: **0** ☒ **Corroded**

Corroded rungs

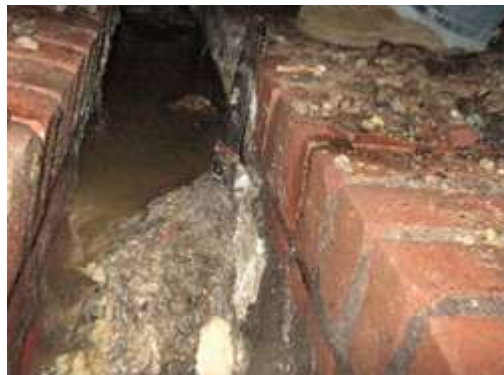
Defect 2

Condition: ☐ Sound ☐ Cracked ☐ Root Intrusion ☐ Deteriorated ☐ Leaks ☒ **Debris**

channel debris

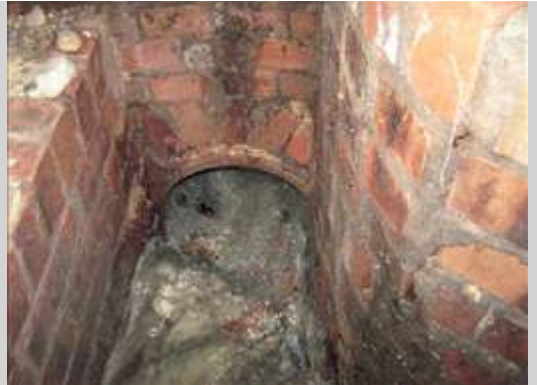
12 O'Clock Outflow

channel at 12 is full of heavy debris and sludge

Deposits: ☐ None ☒ **Mud** ☒ **Sludge** ☐ **Debris** ☐ Grease

Silt Depth: **8** (in.) Deposits Extent: **Heavy**

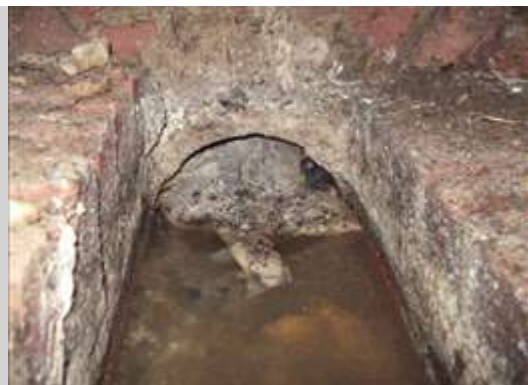
6 O'Clock Inflow

Deposits: ☐ None ☒ **Mud** ☒ **Sludge** ☒ **Debris** ☐ Grease

Silt Depth: **7** (in.) Deposits Extent: **Heavy**
